**FLG INTERNATIONAL LTD**

TECHNICAL SECTION  
FRAME 9001E

## ROTOR DATA

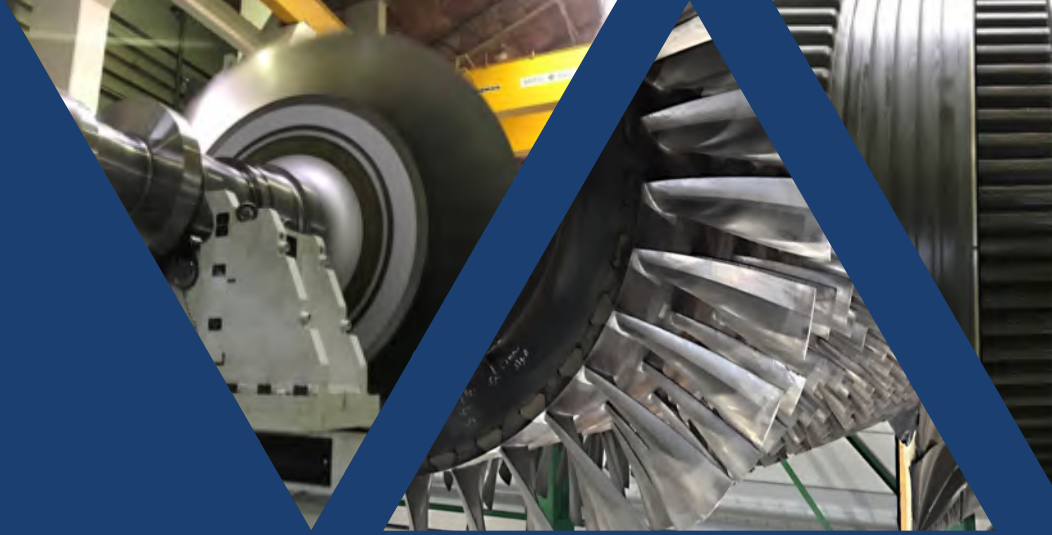
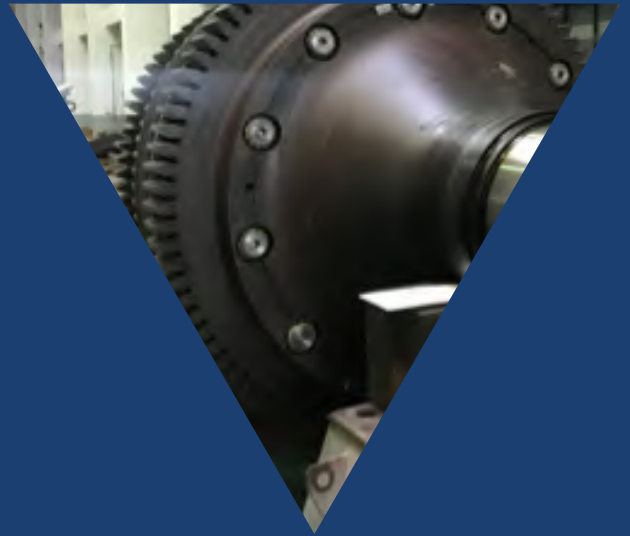
Compressor Rotor  
Turbine Rotor

Both Turbine and Compressor Rotors have been operated and maintained according to OEM standards. The Turbine and Compressor Rotors have been fully repaired and in Dec 2019 the rotors were fully inspected and went through a complete Run out check and balancing and are confirmed to be in line with OEM spec/standard.

The Rotors are ready to be installed and operated. Rotors are currently stored in Pressurized Containers with N2 @ 3psi

No.	Description	Serial No.	Hours / Starts
1	Compressor Rotor	G01443621	127,265 / 283
2	Turbine Rotor	G0361449	80,715 / 474
